Monitoring Data RecordProject Title: R-2206B (NC 16 Bypass) COE Action ID: 200431320Stream Name: UT to Forney Creek (Site 10B) WQC Number: 3476City, County and other Location Information: Lincoln County, NC 16 Bypass

(Sta. 159+00 LT.-L-)

Date Construction Completed: 3-3-08 Monitoring Year: (4) of 5Ecoregion: _____ 8 digit HUC unit 03050101

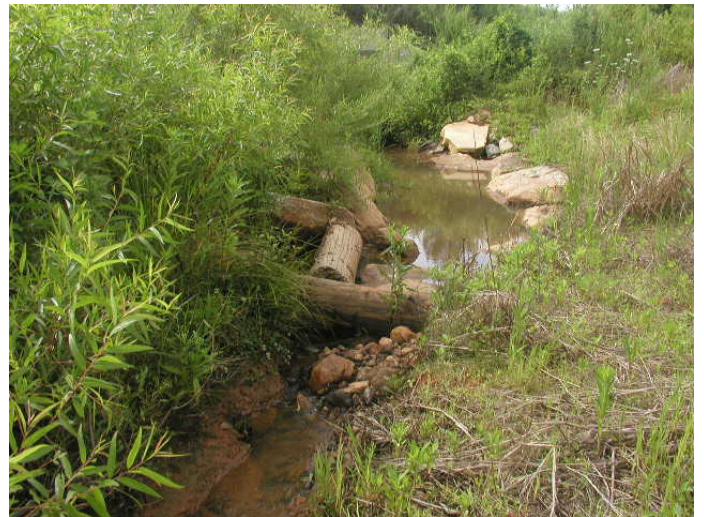
Photo Point #5 (Downstream)

Date 6/16/11	Sta. 160+00-L- (additional photo)	Sta. 159+40-L- (photo point #5 downstream)	Station Number	Station Number	Station Number
Structure Type					
Is water piping through or around structure?	Water piping under crossvane	Water piping under crossvane			
Head cut or down cut present?	Headcut				
Bank or scour erosion present?		Erosion behind left arm of last crossvane			
Other problems noted?

UT to Forney Creek is stable for the Year 4 Summer evaluation, except for the two areas noted below in the chart. The last crossvane and the right bank looking downstream were re-worked in 2010 per DWQ's comments from October 2009. This area @ Sta. 159+40 -L- has continued to have some instability since this work was complete. A site visit was conducted on June 16, 2011 with the regulatory agencies and NCDOT personnel present. It was determined at that meeting that the area at Sta. 159+40 -L- needs to be repaired. NEU staff is currently coordinating with division personnel to repair this area. NCDOT will continue to monitor this stream restoration project.

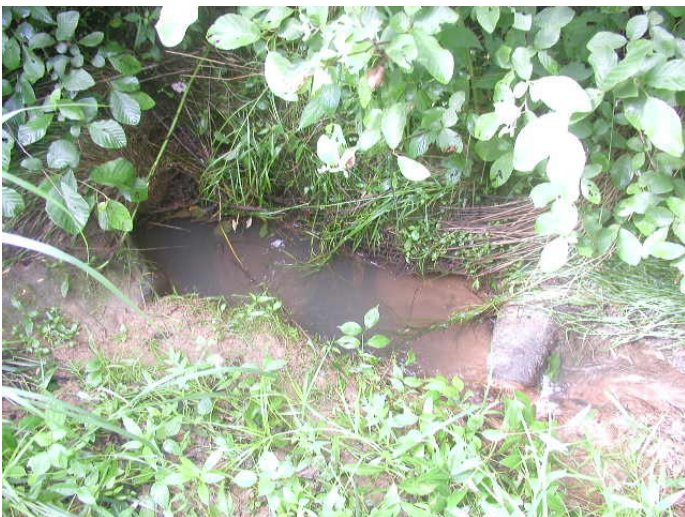
Headcut at Sta. 160+00 downstream of Cross Section #6
Year 4 Summer – June 2011
